Lockerbie Old School Community Hu Feasibility Report

Lockerbie Old School Community Hub Feasibility Report

For Lockerbie Old School Committee By John Gilbert Architects and Reid Associates Issued June 2019

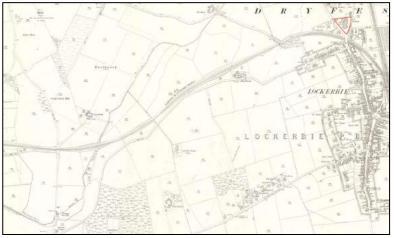
The map below shows the area of Lockerbie in 1899, 28 years after the construction of the Old School. The town is simply a single street with the Dryfesdale Public School at the Northern end of the street.

The maps illustrate how Dryfesdale school has been a pivotal part of the urban development of Lockerbie over the last 140 years.

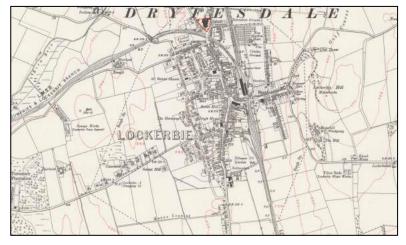
The map below shows Lockerbie in 1932 as Lockerbie extends to the west.

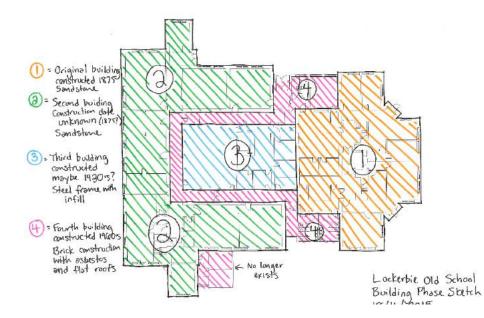
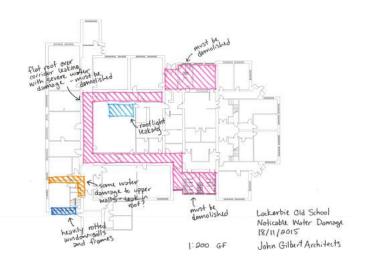
The diagrams below shows the key problem areas in the building related to the various ages of the building. The correlation between the building defects and the 1960's infill development can clearly be seen. The 2019 survey noted significant deterioration of the visible elements of this part of the building.

This is the newest portion of the building and is in the worst condition. The roof area shown in hatched pink on the sketch to the right is all flat and poorly detailed when constructed. This has resulted in substantial water ingress all along the corridor and in the toilet areas. It is uneconomical to repair this part of the building and its demolition should be considered.

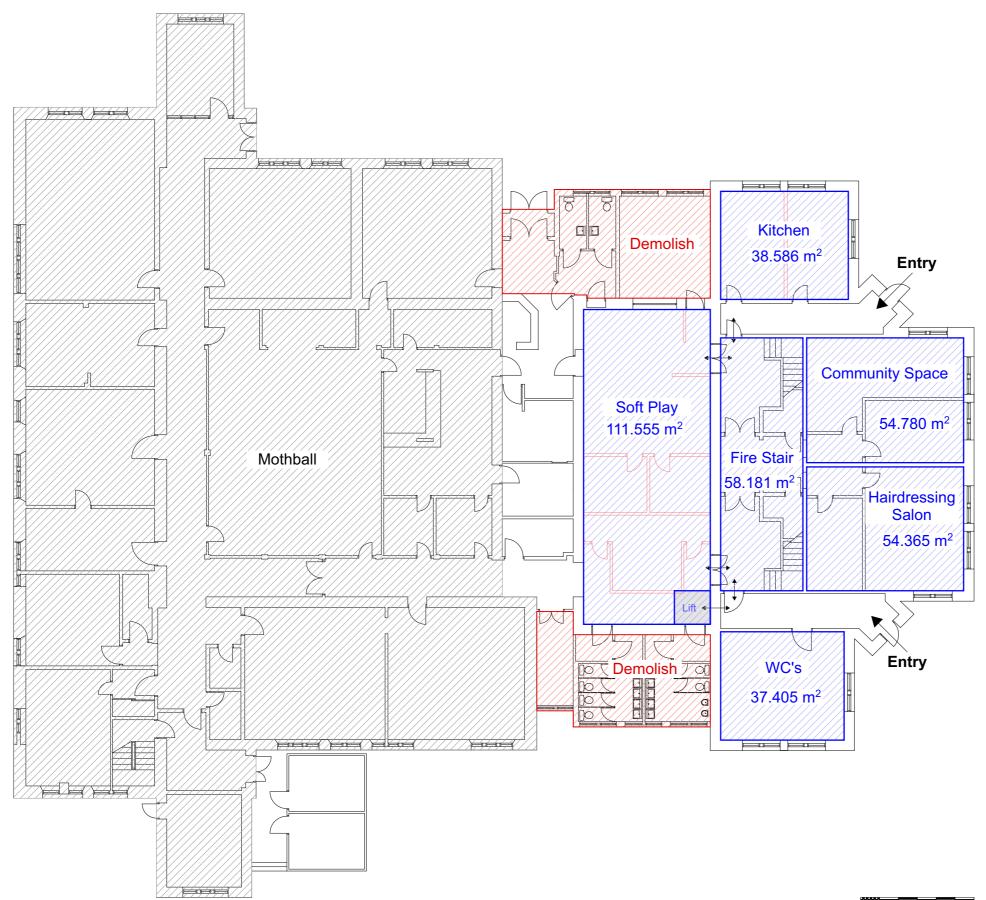
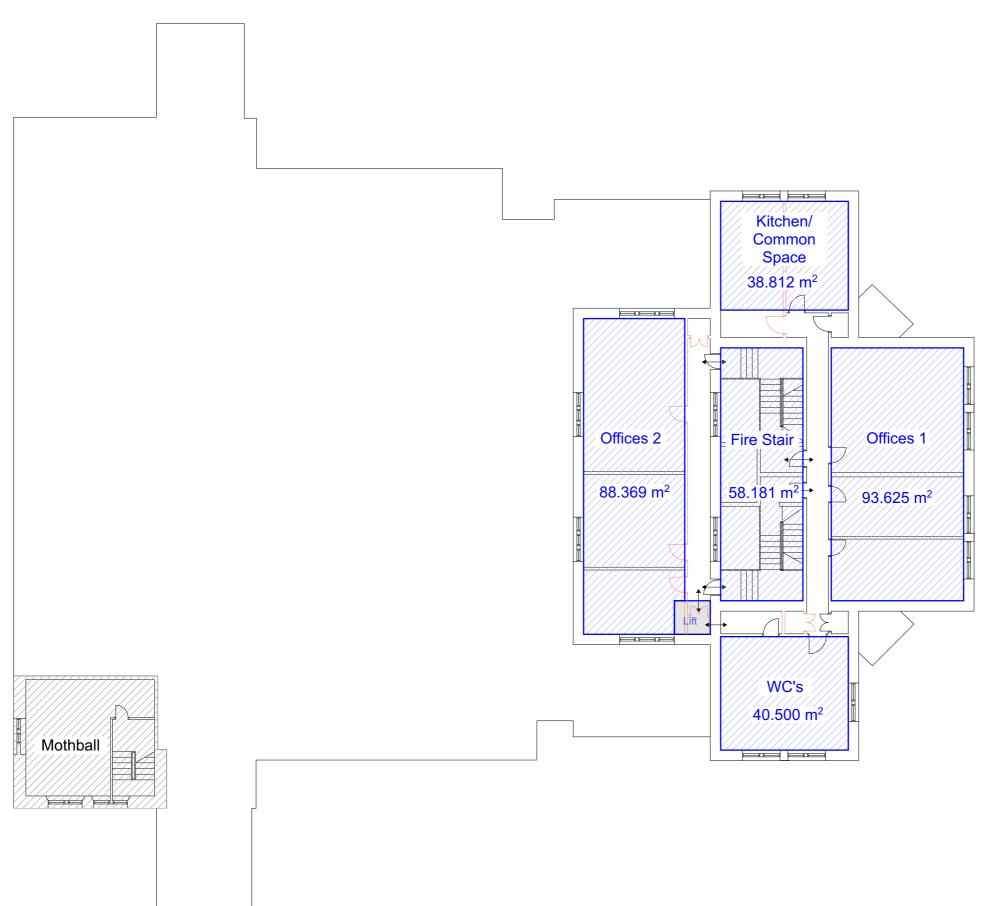
Notes / Key:
N
Suggested walls to demolish
First Floor: 400m ²
Offices 1: 94m ² Offices 2: 88m ² Kitchen: 39m ² Wc's: 40m ²
Do not scale from this drawing. All existing dimensions to be checked on site prior to commencement of works or manufacturing of components. Any discrepancies to be brought to the attention of the architect - if in doubt, ask.
This drawing is the copyright of John Gilbert Architects Ltd. No copying or distribution of this drawing or any part thereof is permitted without prior written permission.
John Gilbert ARCHITECTS
201 White Studios, 62 Templeton Street, Glasgow, G40 1DA Tel: 0141 551 8383 Web: www.johngilbert.co.uk
Client Lockerbie Old School Community Hub
Project LOCKERBIE OLD SCHOOL
Title FIRST FLOOR PLAN (OPTION 2)
Project Status FEASIBILITY
Job No Scale at A3 03819 1:200
Drawn by Date of issue
Rev. Ammendment Date
Drg No. Rev [PP]12

The front part of the building can accommodate the following activities on the ground floor:

- Soft play
- Community meeting room
- Kitchen
- Beauty Training space (D&G College)
- Associated WC's and ancillary space

On the upper floors we are proposing a number of flexible office / workshop spaces. Core anchor tenants for this space have been identified as part of the business planning process, including:

There is lift access to all floors and the upper floors will have separate WC's and kitchen / common space.

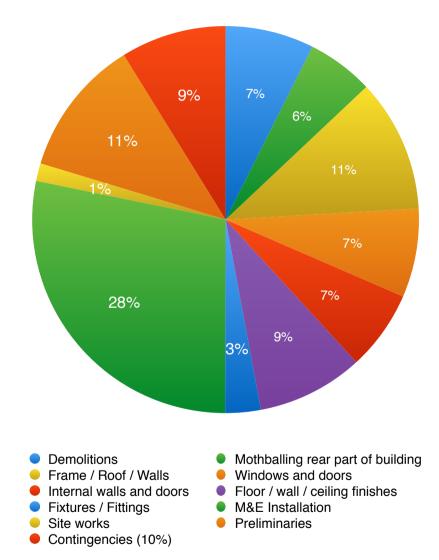
It can be seen from this budget, taking early VAT advice will be important. Based on this budget, the percentage breakdown is illustrated below.
